NOISE LAB
REPORT Number ASTM-2018_ES_211-I101_43432_E

Tests : Laboratory measurement of airborne sound insulation of building elements
Product name : **KINLAYMENT 5mm**

Reference norm :
 ASTM E 90 - 04 Standard Test Method for Laboratory Measurement of
 Airborne Sound Transmission Loss of Building Partitions and Elements

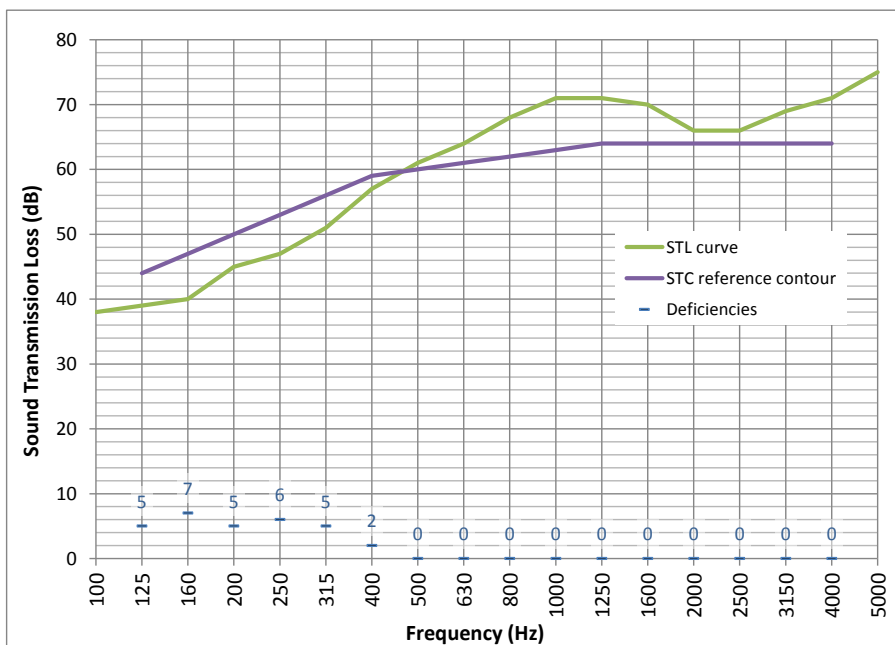
Sound Transmission Loss Test Data

Description of the test setup:

45 mm	= (1.77 inch)	prefab anhydrite screed slab
5 mm	= (0.20 inch)	KINLAYMENT 5mm
140 mm	= (5.51 inch)	heavyweight standard floor = solid reinforced concrete slab

frequency Hz	STL one third octave dB
50	
63	
80	
100	38
125	39
160	40
200	45
250	47
315	51
400	57
500	61
630	64
800	68
1000	71
1250	71
1600	70
2000	66
2500	66
3150	69
4000	71
5000	75

Sound Transmission Class STC (dB): 60

f	R	(*)	(**)	STL
(Hz)	(dB)			(dB)
50		b		
63				
80				
100	38.1			38
125	39.0			39
160	40.4			40
200	45.4			45
250	47.0			47
315	51.0			51
400	57.0			57
500	60.7			61
630	63.7			64
800	67.9	b		68
1000	70.5	b		71
1250	70.8	b		71
1600	69.5			70
2000	66.0			66
2500	66.4			66
3150	69.1	b		69
4000	71.2	b		71
5000	74.6	B		75

ASTM E 413 - 10	Sound Transmission Class STC (dB)	60	Sum of Unfavorable Deviations [dB] -30
			Max. Unfavorable Deviation [dB]:
			-7 at 160 Hz

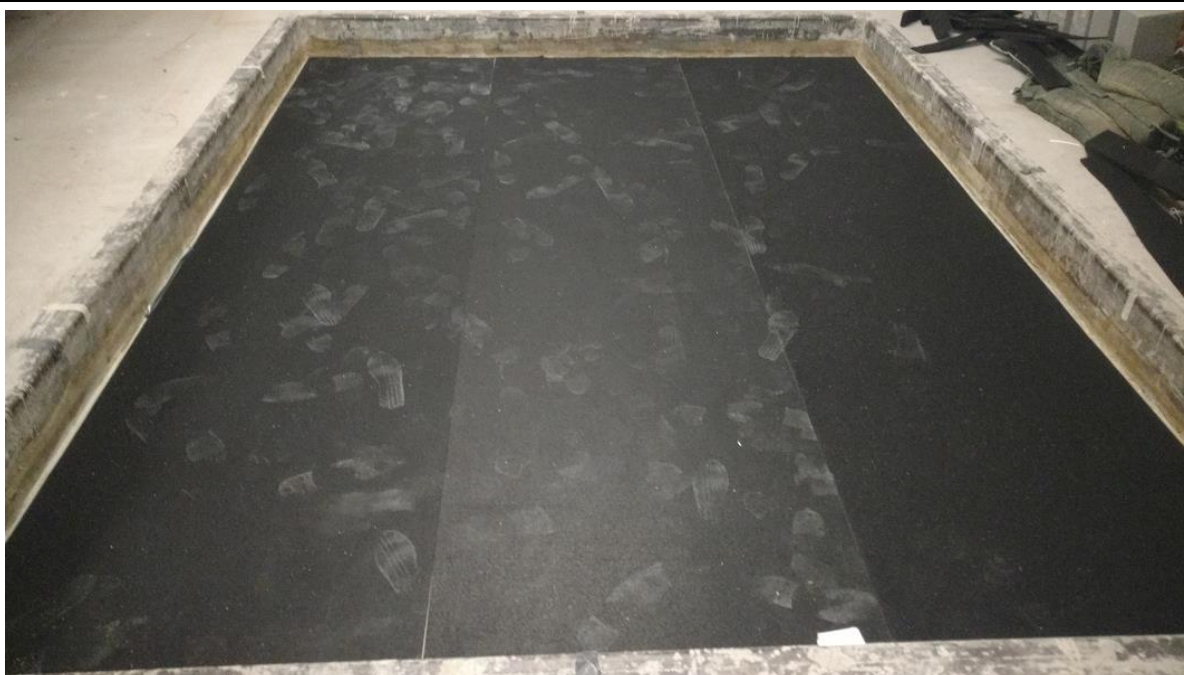
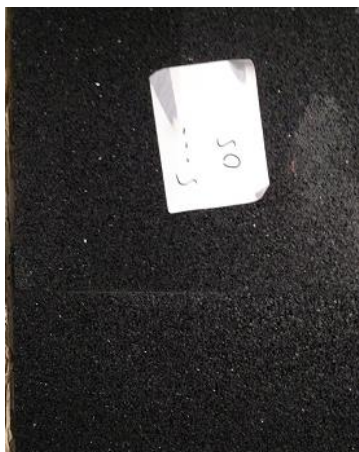
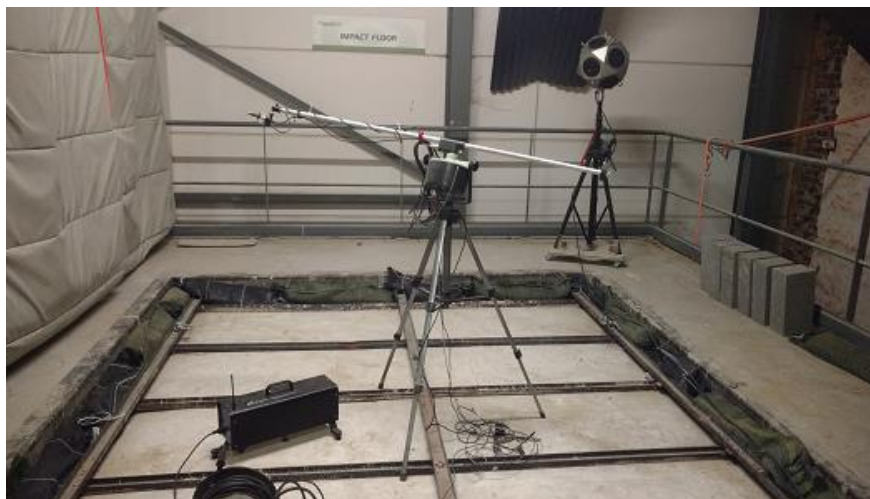
ANNEX 4: photographs of the test element or the test arrangement

The floating floor underlayer product was placed on the standard concrete floor.

Then a prefab anhydrite screed slab was placed on top.

The topfloor had no rigid contact with the test opening construction. Gaps between the topfloor and the test opening were filled-up with sound-absorbing material.

Additionally sandbags were placed around the perimeter edges

Remark: the sound-absorbing material and sandbags are not a part of the floating floor product.

Description of the test element as a layered structure

Thickness (mm)	ρ (kg/m ³)	m" (kg/m ²)	m" (PSF)	Description of the layer
1	45		90	18.4	prefab anhydrite screed slab
2	5				KINLAYMENT 5mm
3	140	2300	322	65.9	heavyweight standard floor = solid reinforced concrete slab
4					
5					
6					
7					
8					
9					
10
