# NOISE LAB REPORT Number ASTM-2018\_ES\_211-I107\_43432\_E

| Customer : | Kinetics Middle East, LLC<br>P.O. Box: 37670<br>Dubai<br>United Arab Emirates | | | |
|---|--|---|--|--|
| Tests :<br>Product name : | Laboratory Measurement of the Effectiveness of Floor Coverings in Reducing Impact Sound<br>Transmission Through Concrete Floors.<br>KINLAYMENT 4mm | | | |
| Normative references:<br>ASTM E2179 - 03 (2009) | Standard Test Method for Laboratory Measurement of the Effectiveness of Floor Coverings in Reducing<br>Impact Sound Transmission Through Concrete Floors | | | |

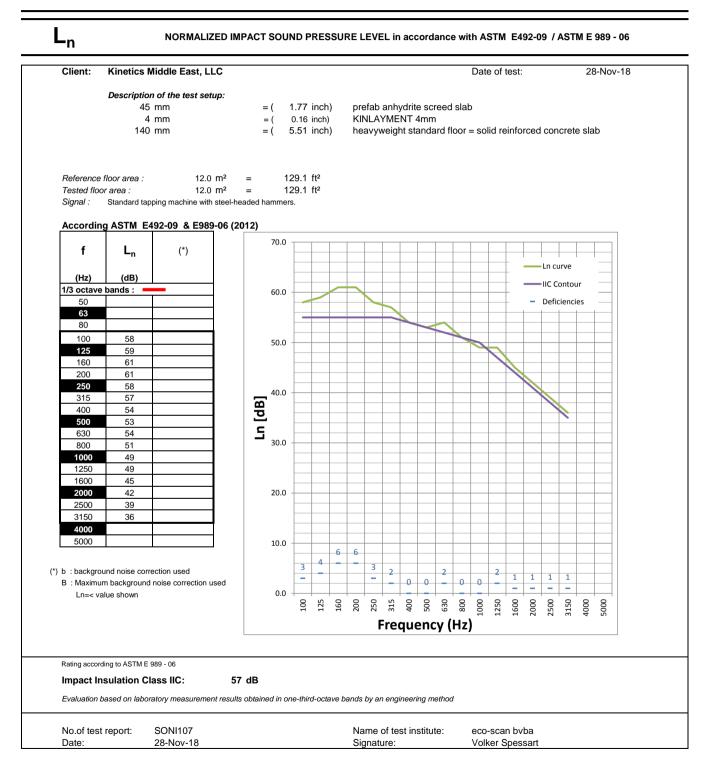
NORMALIZED IMPACT SOUND PRESSURE LEVEL

| Client: Kinetics Middle East, LLC | | | | | | Date of test: | 28-Nov-18 |
|---|---|---|---|---|---|---|---|
| | | 140 mm | | = ( 5.51 inc | h) heavyweight | standard floor = solid reinforced con- | crete slab |
| f | L <sub>0</sub> (f) | L <sub>c</sub> (f) | 1 | f | L <sub>d</sub> (f) | L <sub>ref</sub> | L <sub>ref,c</sub> |
| | | IIC in dB | - | | FM E2179-03 | IIC <sub>c</sub> in dB | ∆IIC in dB |
| × ⊏989 | -06 (2012) | 57 | 1 | άE | 989-06 (2012) | 51 | 23 |

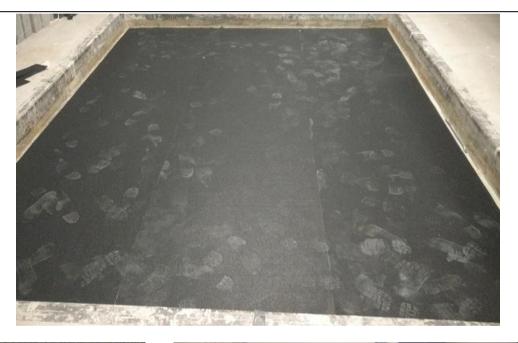
## ANNEX 2: photographs of the test element or the test arrangement

The floating floor underlayer product was placed on the standard concrete floor.

Then a prefab anhydrite screed slab was placed on top.

The topfloor had no rigid contact with the test opening construction. Gaps between the topfloor and the test opening

were filled-up with sound-absorbing material.

Additionally sandbags were placed around the perimeter edges

Remark: the sound-absorbing material and sandbags are not a part of the floating floor product.

| | Thickness | | m" | m" | |
|---|---|---|---|---|---|
| 1 | 45 | | 90 | 18.4 | prefab anhydrite screed slab |
| 2 | 4 | | | | KINLAYMENT 4mm |
| 3 | 140 | 2300 | 322 | 65.9 | heavyweight standard floor = solid reinforced concrete slab |
